PASSAIC RIVER BASIN
BEAR SWAMP BROOK, PASSAIC COUNTY
NEW JERSEY

BEAR SWAMP LAKE

DAM NO. I

PHASE I INSPECTION REPORT
NATIONAL DAM SAFETY PROGRAM

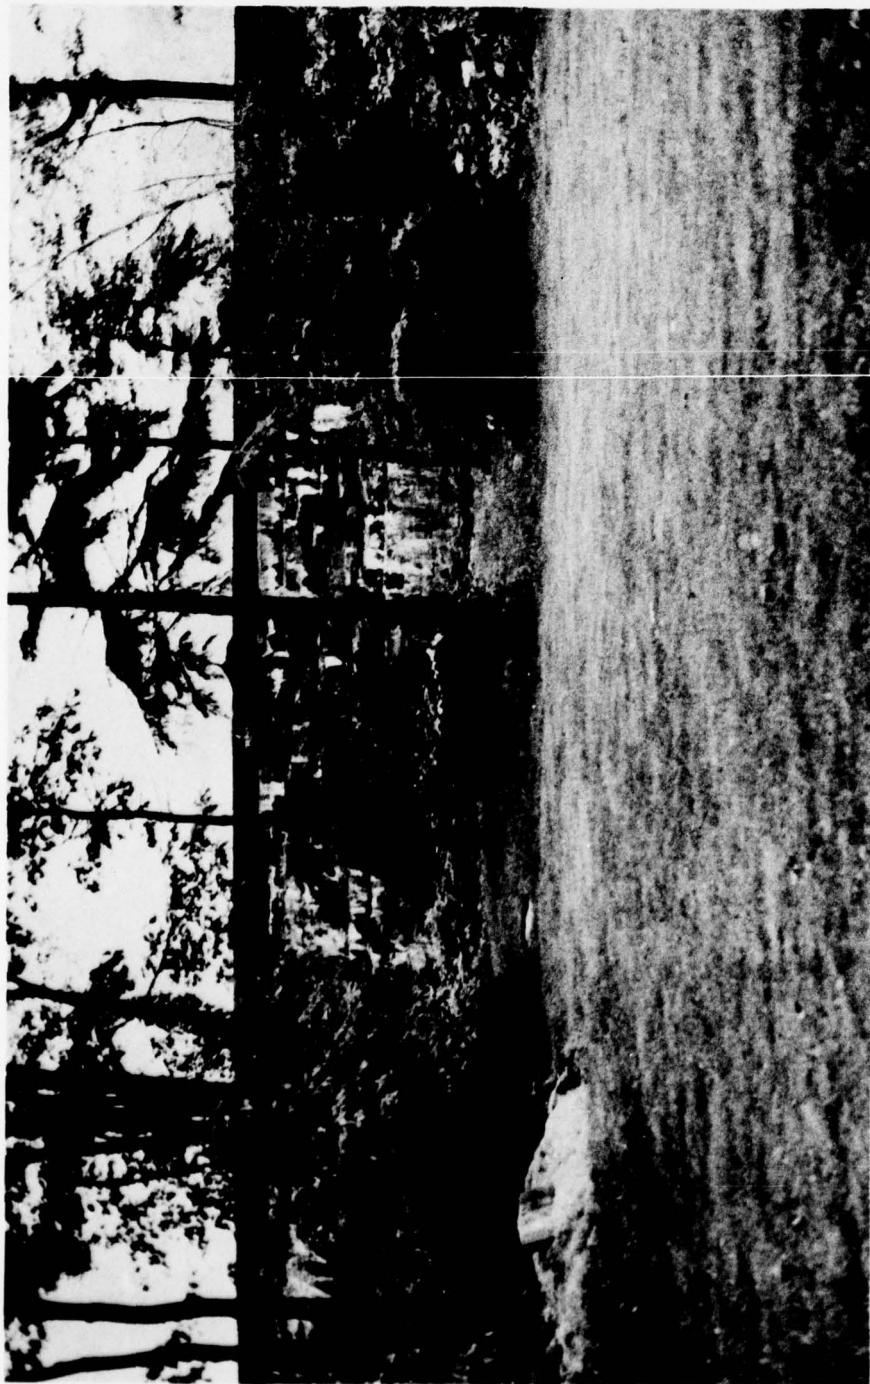
June 27, 1978

BEAR SWAMP DAM #1
View of dam from downstream.

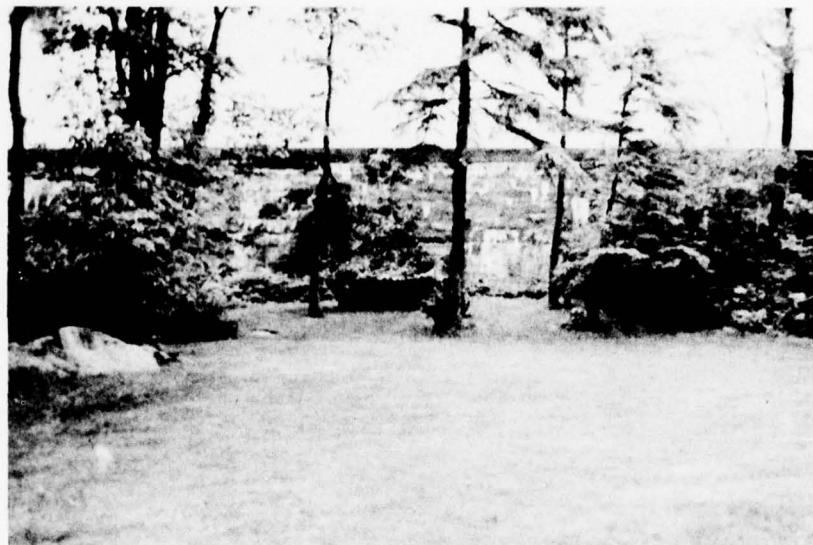
Photo 1 - View of dam from downstream.

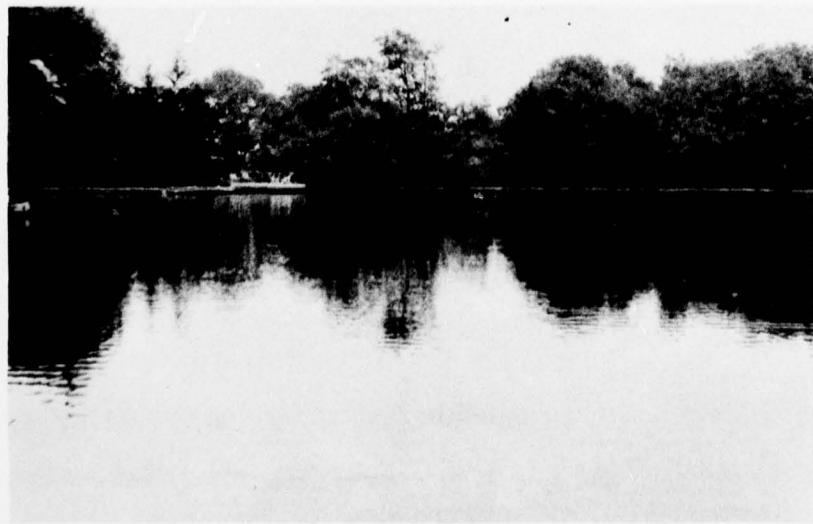
Photo 2 - View of dam from upstream left shoreline.

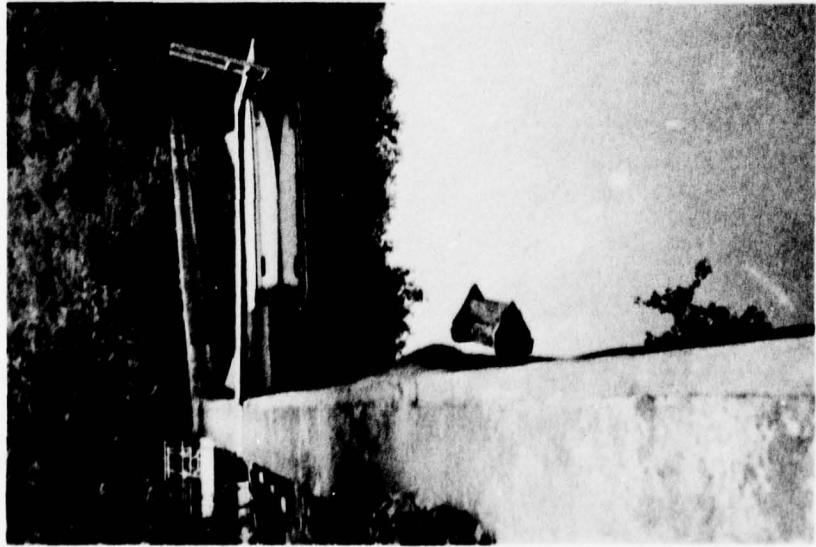
Considerable concrete spalling was observed on the downstream face of the dam. The upstream face of the dam was resurfaced with 4 to 6 inches of concrete, reportedly around 1971. There was no evidence of structural cracking. Construction and monolith joints appeared to be tight and basically in good condition. Some minor seepage had occurred through construction joints as evidenced by leaching, however, no flowing seepages were observed. There were no indications of either horizontal or vertical movement of the structure.

Photo 3 - View of dam crest from left abutment showing repair slab on upstream.

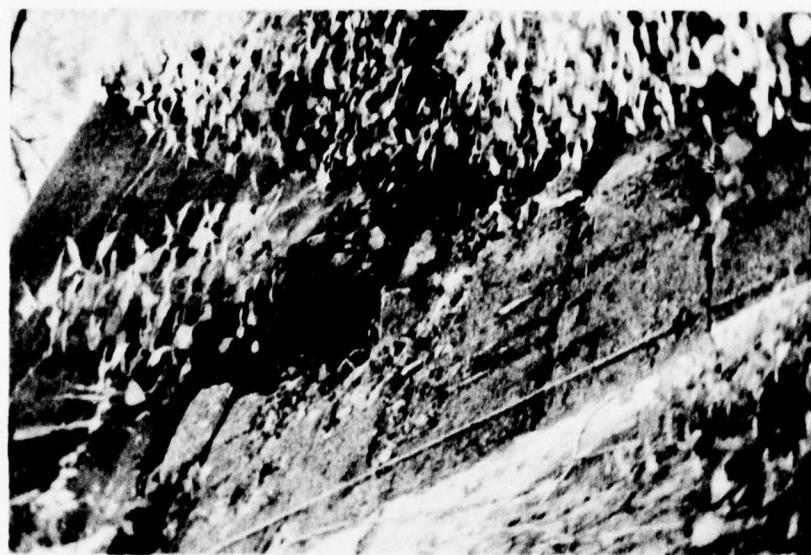
Photo 6 - Deterioration of concrete on downstream face.

Areas of deteriorated and spalled concrete should be cleaned and patched annually to prevent progressive damage.

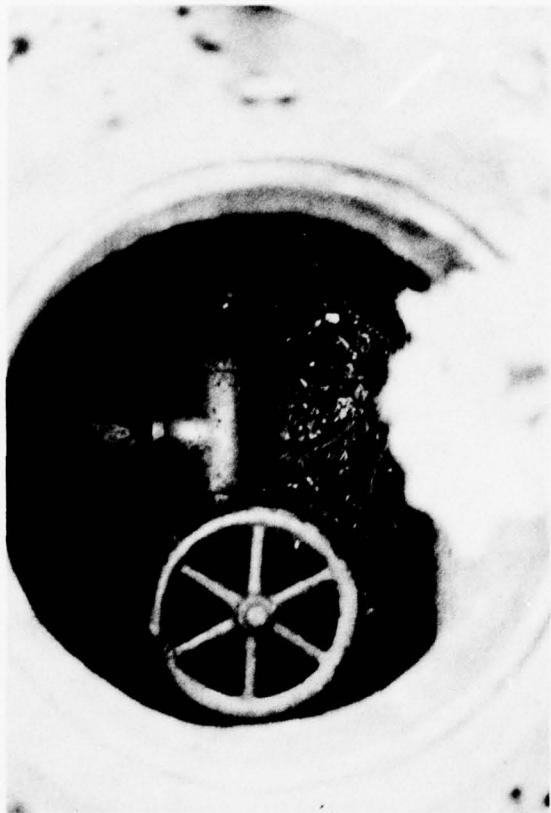
Photo 9 - Gate valve in vault on low level outlet works.

The low level outlet should be tested to see if it is operable and made operable if it is not.

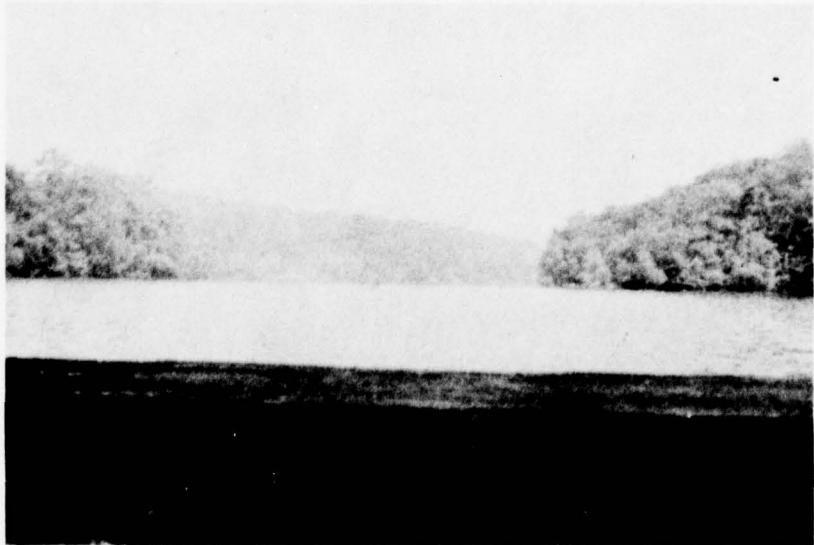
Photo 10 - View of Bear Swamp Lake and shoreline.
